NASA
Technical Memorandum 107439

Thermal Fatigue Testing of $\text{ZrO}_2\text{-Y}_2\text{O}_3$ Thermal Barrier Coating Systems Using a High Power CO_2 Laser

Dongming Zhu and Robert A. Miller
Lewis Research Center
Cleveland, Ohio

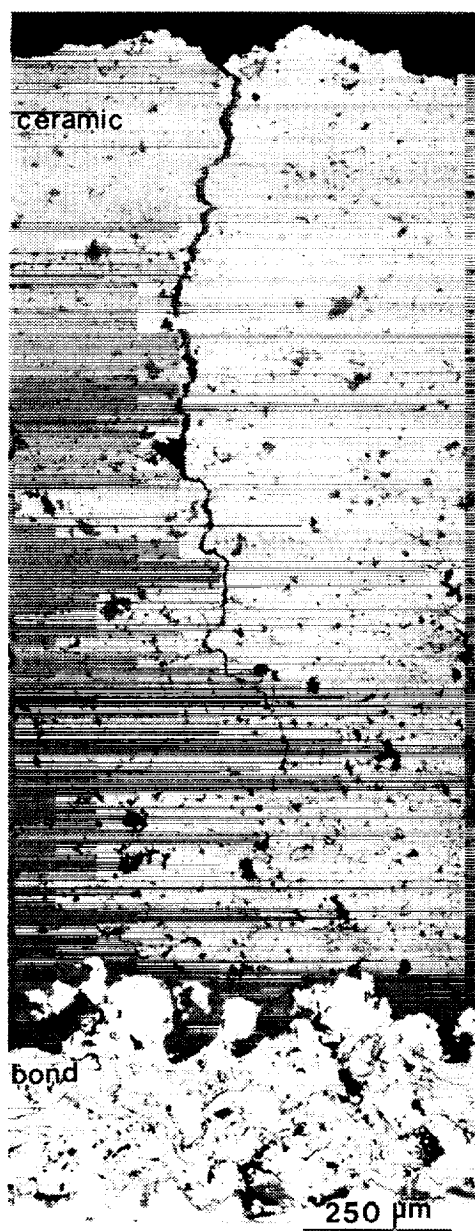
Fig. 8 Optical micrographs of the cross-sections of the ceramic coatings on the angle irons after the laser thermal fatigue testing (30 minute heating and 5 to 6 minute cooling cycles). (a) LCF tested, after total 256 hours heating and 510 LCF cycles, $T_s=850^\circ\text{C}$; (b) Combined LCF and HCF tested, after total 256 hours heating, 510 LCF cycles and 10×10^6 HCF cycles, $T_s=950^\circ\text{C}$.

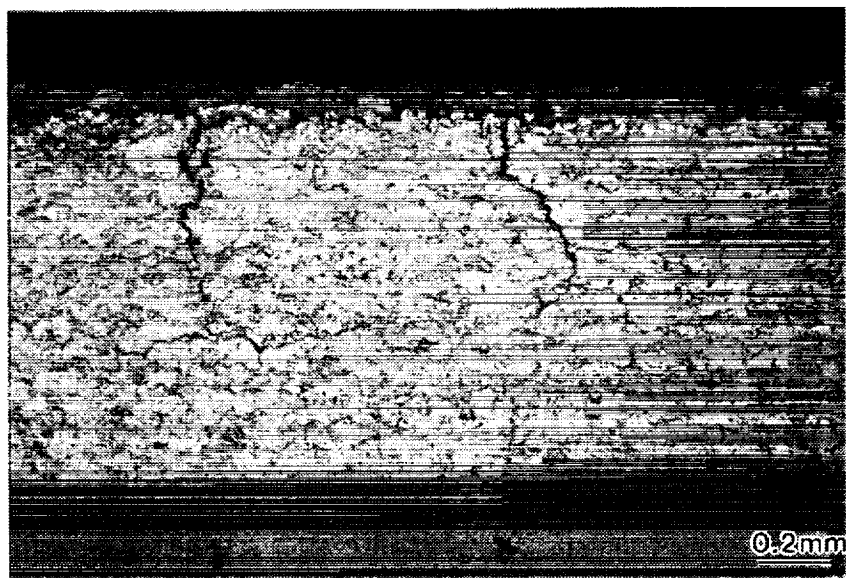
Fig. 12 SEM micrograph of a specimen cross-section showing crack morphology induced by thermal shock tests. The coating experienced 5000 thermal shock cycles at the maximum temperature swing of 750°C.

Figure 11 illustrates the crack growth kinetics under laser thermal shock conditions. It can be seen that higher temperature swing results in faster crack growth rate. The cracks initiated and extended rapidly during the initial stage, then grew in a much slower rate. Although the thermal loading was acting only on the surface layer, the cracks propagated continuously, deep into the coating. These experiments demonstrate the even shallow surface thermal cyclic loading can cause not only surface crack initiation but also propagation. In fact, some of the cracks have reached near the ceramic/bond coat interface after 5000 cycles, when surface temperature swing was about 700°C. A typical micrograph of a specimen cross-section showing crack morphology induced by thermal shock tests is shown in Figure 12.
